LAKE FREDERICK DAM  
ORANGE COUNTY, NEW YORK  
INVENTORY NO. 769

PHASE I INSPECTION REPORT  
NATIONAL DAM SAFETY PROGRAM

DECEMBER 1978

HUDSON RIVER BASIN  
LAKE FREDERICK DAM  
INVENTORY NO. 769  
PHASE I INSPECTION REPORT

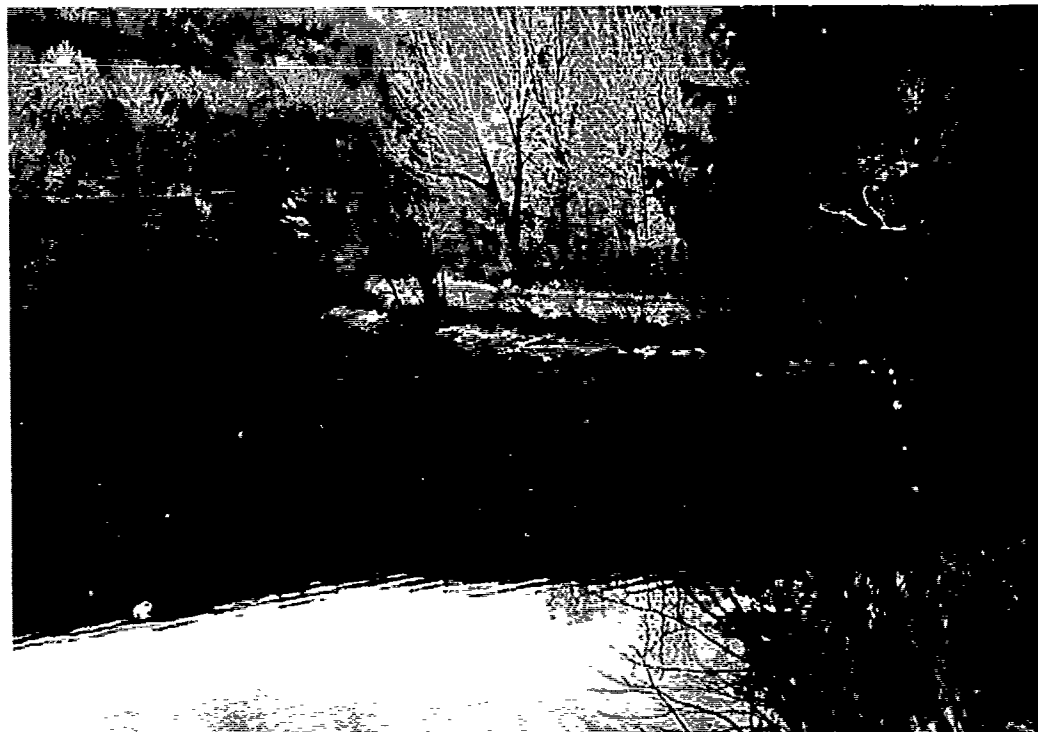
The upstream slope is in generally fair condition. Along the entire length of the slope, about one foot below the crest of the dam and at what appears to be the normal water level, erosion has created about a one foot high vertical step. At several locations this erosion has begun to erode the crest edge. In addition there are trees, saplings, bushes and tall grass growing on the slope.

3. VIEW OF UPSTREAM SLOPE OF DAM, NOTE VEGETATION

- 4) Remove heavy brush, shrubs and saplings and debris from all locations on the embankment. On the downstream slope larger conifers, but not deciduous hardwoods, should be removed. The remaining trees should be inventoried and their condition monitored. If a tree dies, the area around the tree should be monitored for seepage.

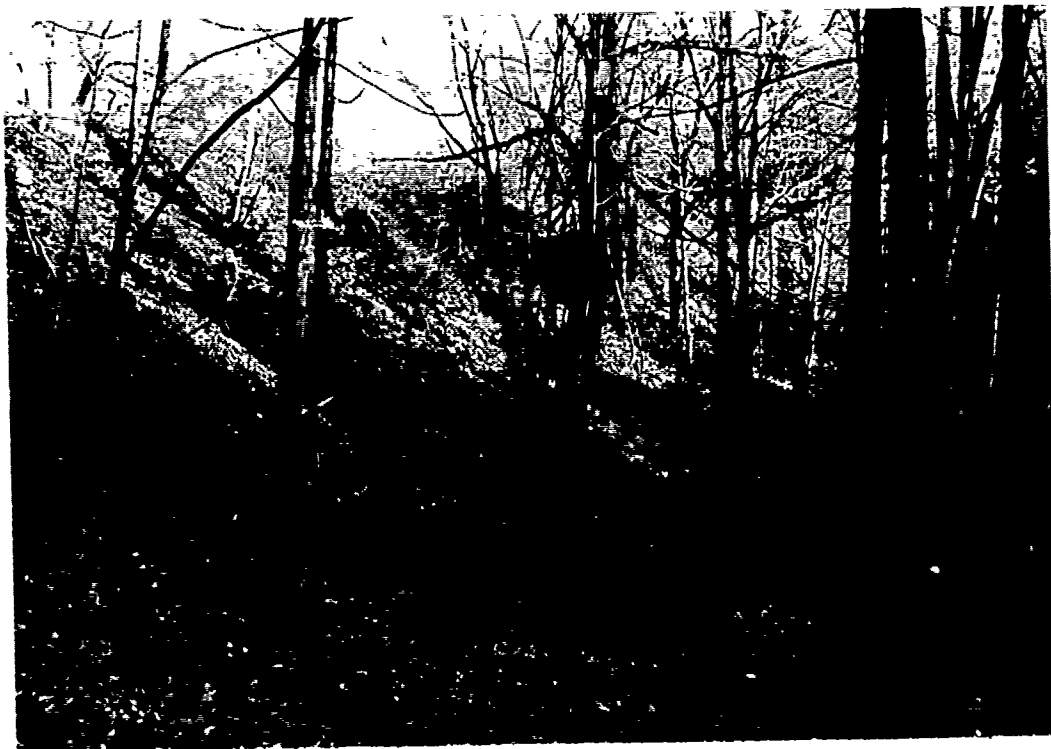
The downstream slope is in generally good condition with only minimal evidence of sloughing and some small erosion gullies near the crest. The slope, which for the most part is gravelly, is covered with trees, saplings, bushes and substantial debris; however, there is little to no ground cover. Evidence of seepage was noted at the toe of the dam about 100 feet to the right of the spillway. The seepage has created a wet area about 15 feet by 30 feet. The total seepage from this area is estimated at about 3 to 5 gpm. The flow from the area follows a drainage channel along the toe of the dam and apparently has been caused by runoff.

4. VIEW OF DOWNSTREAM SLOPE OF DAM. NOTE EXTENSIVE TREE GROWTH.

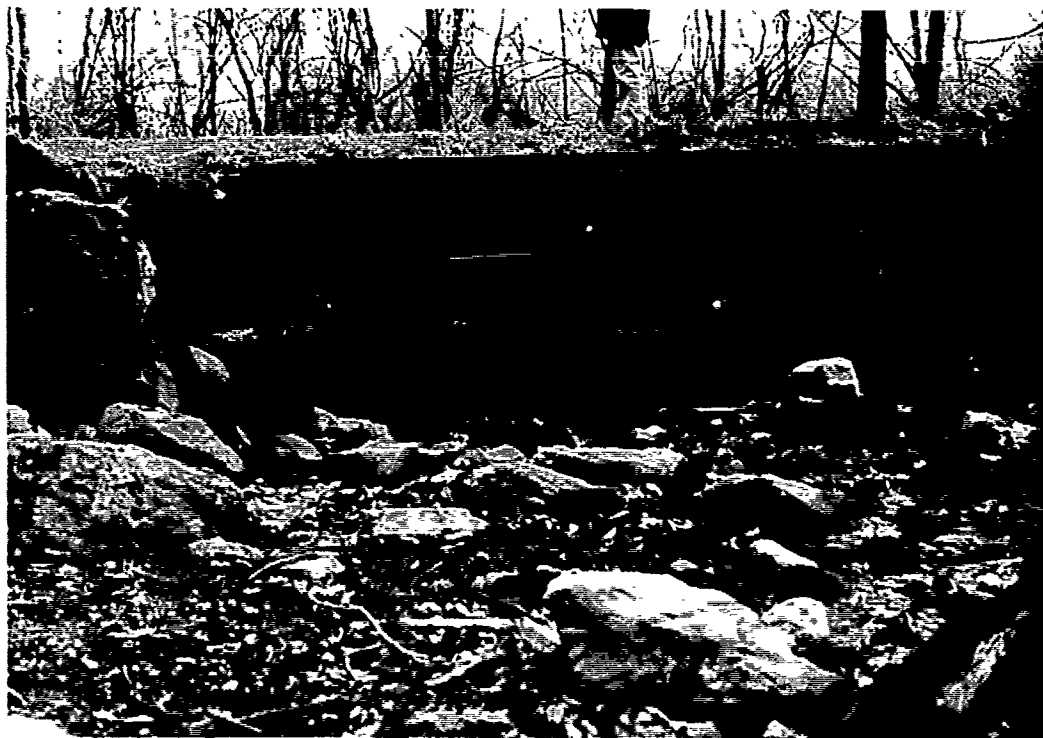
The spillway appears to be in generally fair condition. The concrete surface is cracked and spalled at several locations and there are some underlying stones missing. The sill has been broken off from the left side of the spillway leaving an irregular surface about 5.5 feet long. This condition, in effect creates a two level sill with a 6 inch difference. The downstream stepped chute is in generally good condition with little spalling of the concrete surface and only a few underlying stones missing.

5. VIEW OF BROKEN SPILLWAY CREST LOCATED UNDER BRIDGE.

- 2) Repair the concrete and loose stone along the training walls and spillway chute, adding new pointing where necessary.
- 3) Remove the debris and trees from the spillway channel.

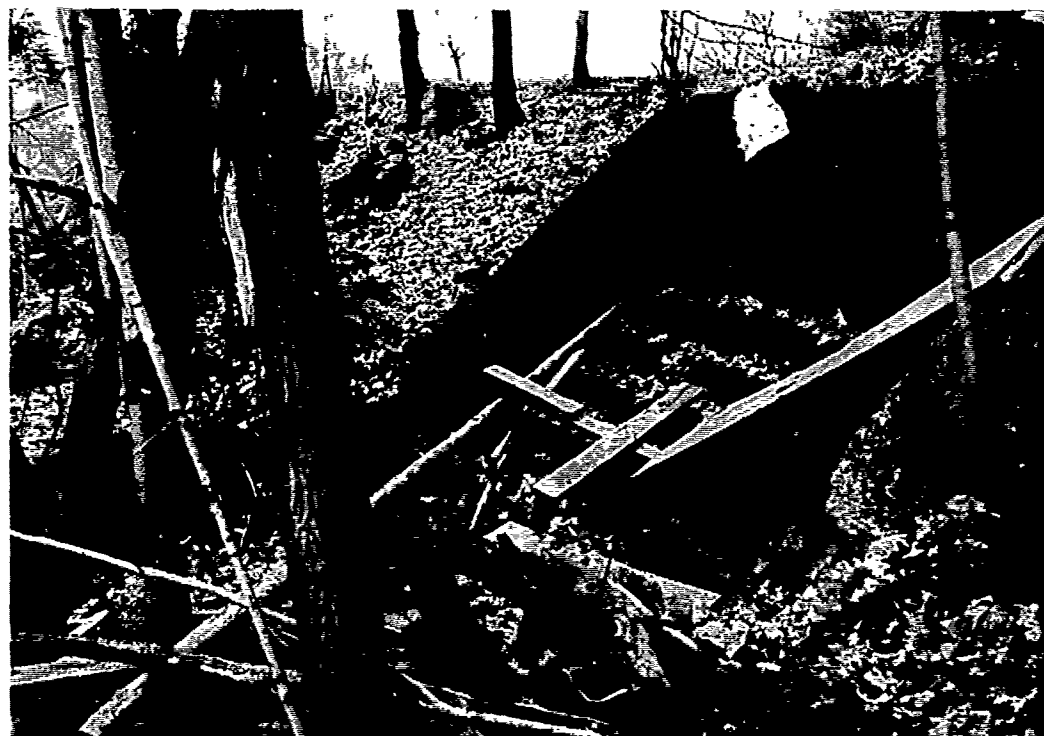
6. VIEW OF DOWNSTREAM FACE OF SPILLWAY. NOTE EXTENSIVE DEBRIS.

The concrete caping  
is cracked and spalled at several locations and some  
underlying stones are missing. At downstream face there  
is substantial debris.

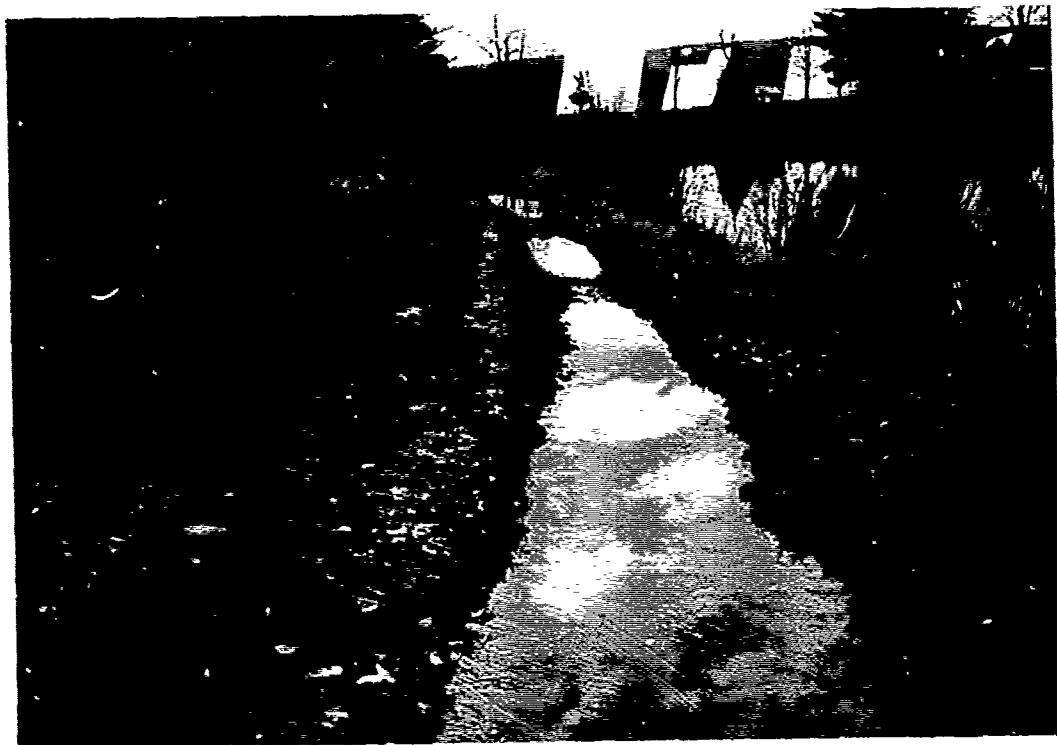
The embankment appears to be in generally good condition. The horizontal and vertical alignments of the crest are generally good except for some rutting and 6 inch deep depressions. This condition appears to have been caused by vehicular traffic which has also removed a substantial quantity of the grass surface. The remainder of the grass appears to have been cut this year. A single animal burrow was found on the crest.

10. VIEW OF RUTS AND DEPRESSIONS ON DAM CREST. NOTE NON-SODDED AREAS.

- 7) Refill the ruts, depressions and reseed the crest. Take measures to prevent the reoccurrence of this condition.
- 8) Steps should be taken to determine the location of the low level intake and the existence of any operating controls. If they can be located, consideration should be given to making the low level outlet system operable.

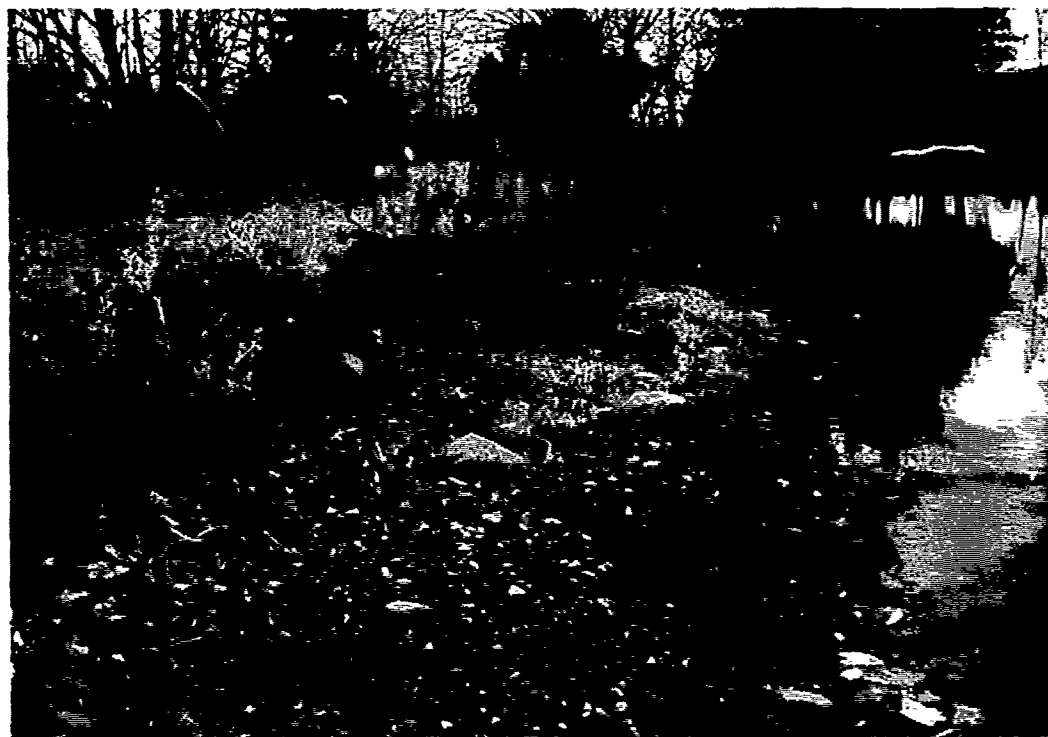
11. VIEW OF EROSION ON UPSTREAM SLOPE. NOTE LACK OF SLOPE PROTECTION.

- 1) Repair the erosion to the upstream slope and provide slope protection to prevent the reoccurrence of this condition.

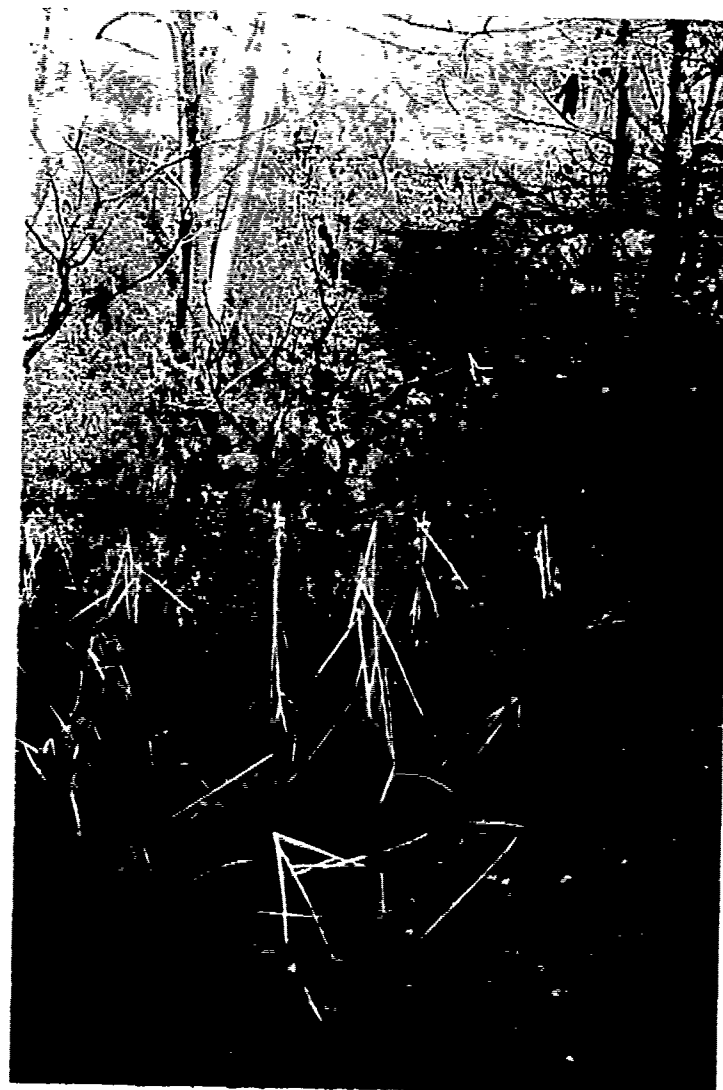
12. VIEW OF SEEPAGE AREA AT DOWNSTREAM TOE.  
NOTE CHANNEL IN FOREGROUND.

- Slope protection
- Removal of vegetation from the dam
- Preparation of an O & M manual and establishment of periodic inspections
- Monitoring of wet zone downstream of the toe of the dam
